BELZONA SUPPORTS RUDDER BEARING TO NAVAL VESSEL

Rudder Bearing Housing

Fretting corrosion of the bearing housing

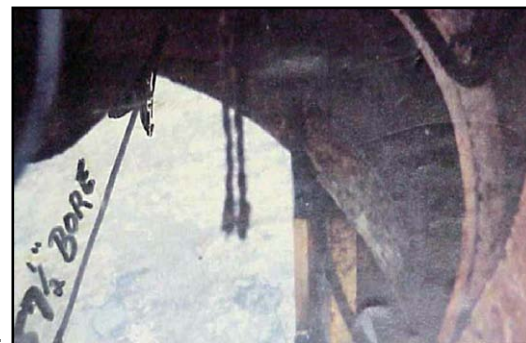
1. USS Detroit AOE-4.
2. 57 1/2" Port lower rudder bearing housing.
3. Housing re-machined.

Belzona® 1111 (Super Metal)

The application was carried out in accordance with Belzona Know-How System Leaflet MPT-6.

The rudder stock running in this 57.5" diameter bearing weighs 62 tons and the displacement of the 26 knots fast combat support ship was 58,300 tons. The repair was in perfect condition at the last recorded inspection 17 years later (vessel is now decommissioned). Subsequently, in 1985 a sister ship had a similar repair.
