## COOLING TOWER COATED WITH BELZONA® 5811 BY SPRAY

Automotive Plant in Southern Ontario

February, 2006

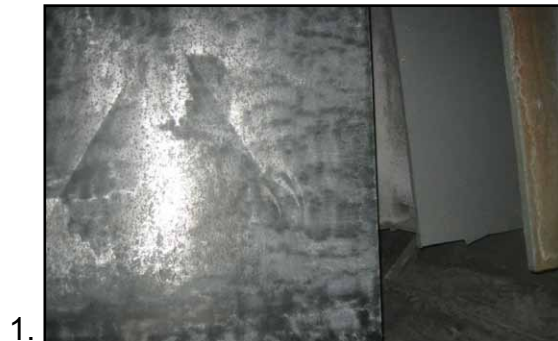
1. Previous coating easily blasted off.
2. Application Pump made ready.
3. Material spray applied to 700 square feet very quickly.
4. Door closures were also coated and job completed.
