BELZONA PROTECTS MIXING TANK

Dairy in Oklahoma, USA

March, 2006

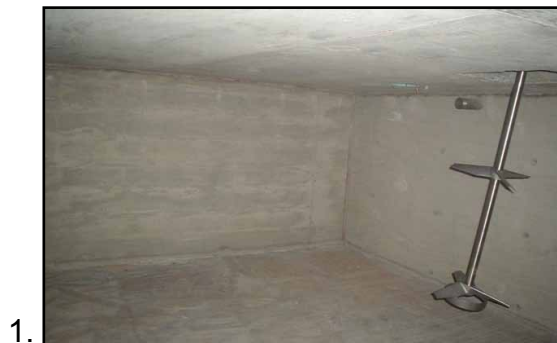
1. Bare unprotected mixing tank.
2. Surface prepared and holes patched with Belzona® 4111.
3. First coat Belzona® 5811 being applied.
4. Final coat Belzona® 5811 applied.
