## BELZONA REBUILDS AND PROTECTS KORT NOZZLES

Tug boat kort nozzles

Kort nozzles badly eroded.

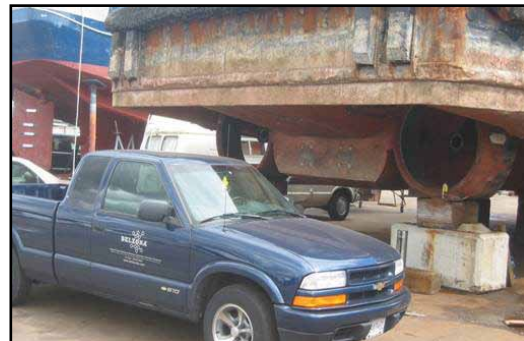
1. View of tug boat in dry dock.
2. View of one of the blasted nozzles.
3. Application of first coat of Belzona® 1341 with application of Belzona® 1311 to fill the voids and depressions in progress.
4. Second coat of Belzona® 1341 applied to complete the application.

Application was carried out in accordance with Belzona Know-How System Leaflets SOS-1 & SOS-2.

Customer had given serious consideration to relining nozzles with a stainless steel insert. This, however, posed a clearance problem. The Belzona solution was the quickest, easiest and most economical solution of the two.
