BELZONA PROTECTS OIL/GAS SEPARATORS

Oil & Gas Producer- North Sea, UK

Internal surfaces of first and second stage separators on an FPSO

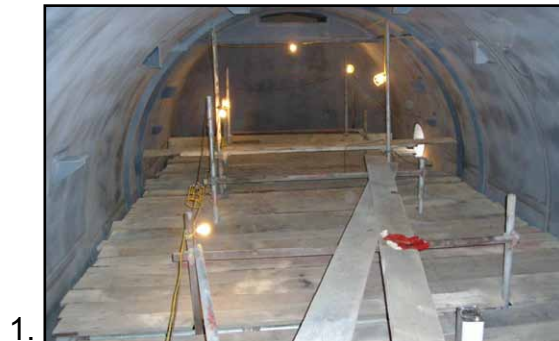
The original glass flake coating had failed in service leading to substrate pitting and corrosion.

1. General view inside separator
2. Stripe coating
3. First coat application ongoing
4. Second coat completed
