CLOSED DRAIN VESSEL PROTECTION USING BELZONA® 1591

International petroleum company - Egypt

New Closed drain vessel.

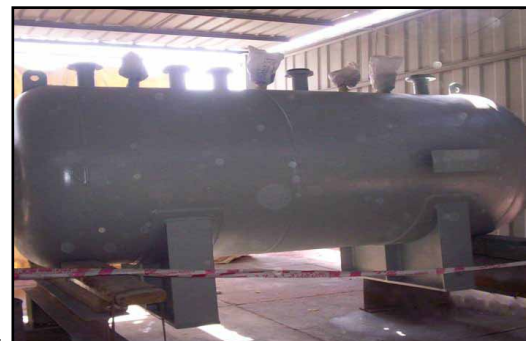
1. General view of the vessel
2. Applying Belzona® 1591 to the vessel
3. Sleeves made from Belzona® 1511 to protect the nozzles
4. Vessel Protected
