BELZONA FLANGE REFORM GIVES FIVE YEARS OF LEAK FREE SERVICE

FPSO North Sea, UK

Oil Transfer Hose on FPSO in the North Sea Oil & Gas Industry

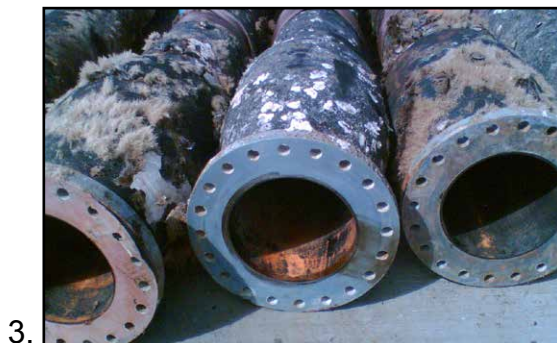
Hose would have been scrapped at a cost of £25,000.00, the string change out would have been delayed leading to a reduction in the unloading frequency from the FPSO. Belzona repair in excellent condition after 5 years in service.

1. Flange face blasted ready for forming
2. Face formed and pressure tested to 16 Bar
3. After 5 years service
4. Close up of the reformed face after 5 years service
