BELZONAS CERAMIC SOLUTION FOR ELEPHANTS FEET

Korean Shipyard - 35,000 DWT Products Tanker

Suction Wells under Elephants Feet" in Chemical Products Tanker"

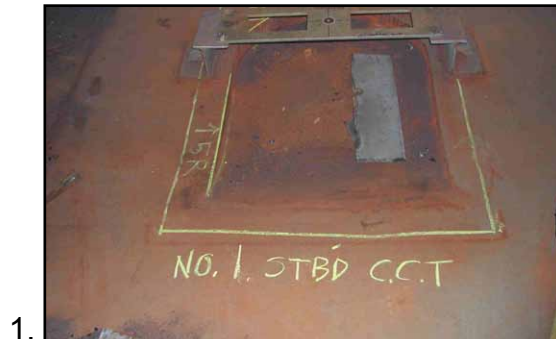
1. Pre-application, showing areas to be radiussed
2. Belzona® 1311 used to stripe coat welds
3. Inspection of Belzona® 1391
4. Completed Belzona® 1391 protected well
