BELZONA COATED CHILLERS 10 YEARS ON

Olympic Stadium: Montréal, Canada

2500 ton Chiller units used for the Olympic Installations

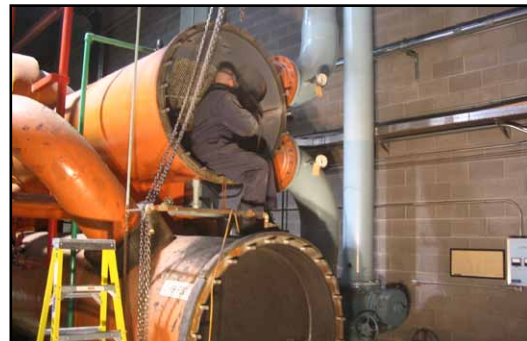
1. The chiller units
2. The covers required minor touch-up
3. The separator bar after 10 years
4. The separator good for another 10 years
