## BELZONA PROTECTION OF INTERNAL & EXTERNAL SURFACES OF LIFT PUMP

High Lift Pump for sea water.

This High Lift Pump for the Refinery was suffering erosion and corrosion on all surfaces.

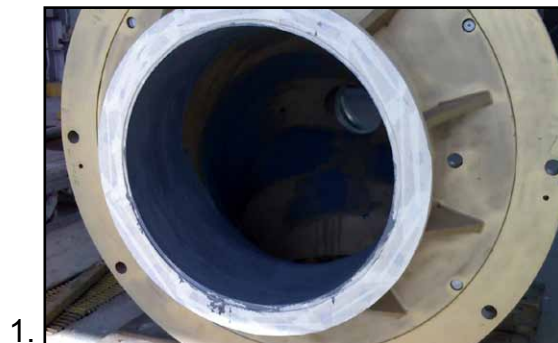
1. Rebuilding the pump head
2. Spools after blasting
3. External coating for spools
4. Completed application
