BELZONA REBUILDS CAVITATED VANES

Power plant, Egypt

Five impellers of cooling pumps

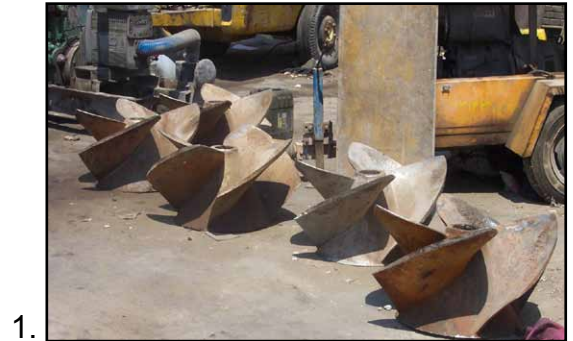
1. General view of the five impellers
2. The cavitated vanes
3. Rebuilding the vanes using Belzona® 1311
4. Finished Impellers coated with Belzona® 1321

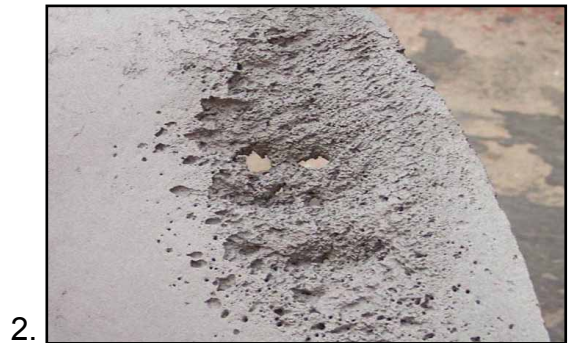
Severe cavitation caused holes, pittings and deformation in the profile of the vanes.

Belzona rebuilt the cavitation and pitting damage in the vanes restoring the correct profile using a simple technique, saving replacement costs and also providing more resistance to future cavitation.
