BELZONA REPAIR TO TURBINE STATIONARY BLADE HOLDER CASING

Geothermal Power Station in Indonesia

Steam Turbine Casing

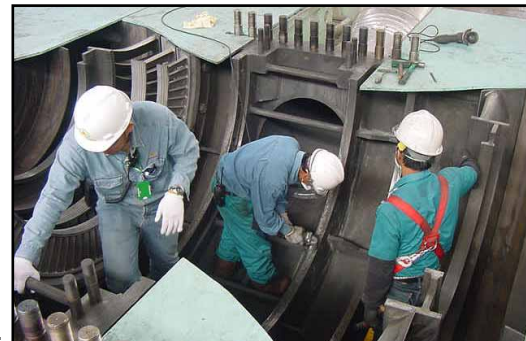
1. View of Turbine Casing
2. Typical damage found on the seating area for the Stationary Blade Holder
3. Application of Belzona 1591 on seating area
4. Job completed with stationary blade holder installed in turbine casing

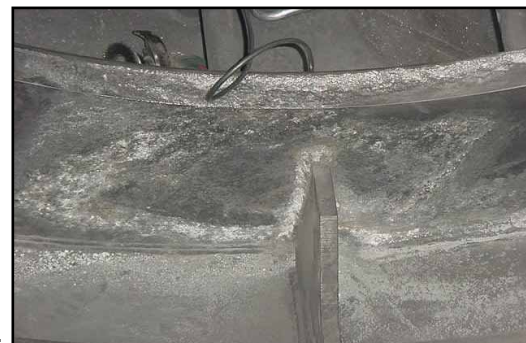
2.

Erosion-corrosion of the Turbine Casing, top and bottom seating area for the Stationary Blade Holder.
