BELZONA TANK BASE SEALING PREVENTS STRESS CORROSION CRACKING

Stainless steel storage tank base seal

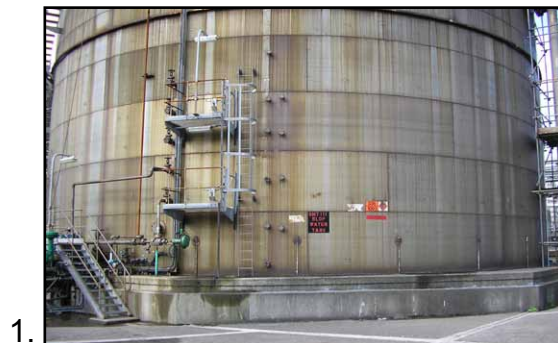
1. General view of Stainless Steel tank
2. Close up of base prior to fitting the system
3. Close up of the applied System
4. Tank Base sealing Systems side by side

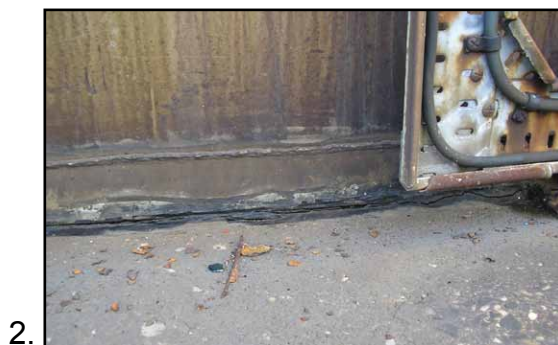
Materials engineers on-site had highlighted that a stress corrosion cracking environment could be created if water was allowed to ingress under the tank floor.
