BELZONA REPAIRS TO ROOFTOP EXHAUST DUCTING

Pet food manufacturer, MO

Rooftop exhaust ductwork

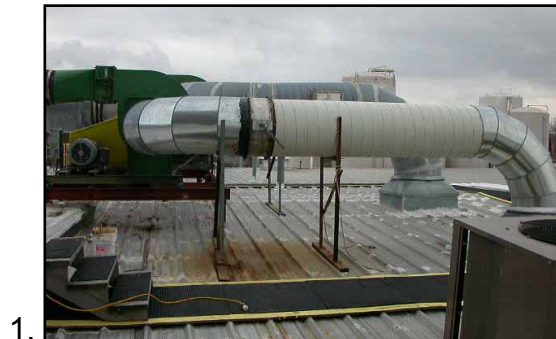
1. First duct joint
2. Close up of first joint repair
3. Second joint repair

Belzona® 2211 (MP Hi-Build Elastomer)

Application carried out using a modified Belzona Know-How System Leaflet VPF-11a
