BELZONA RESTORATION OF HISTORIC FEDERAL BUILDING

Pensacola, Florida

September 2006

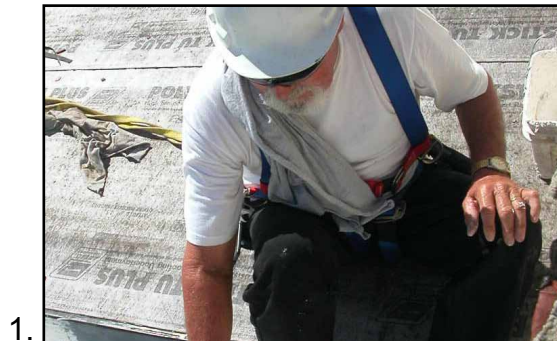
1. Belzona® 3111 being applied
2. Belzona initially applied to gutter seams
3. View of the finished gutter system coated with Belzona® 3111
4. Another view of the finished gutter system coated with Belzona® 3111

Application was carried out in accordance with Belzona Know-How System Leaflet RPA-6. Power wire brushing and degreasing was carried out prior to application.
