## BELZONA REPAIRS CORRODED HEAT EXCHANGER FLANGE

Power plant, Egypt

Heat exchanger

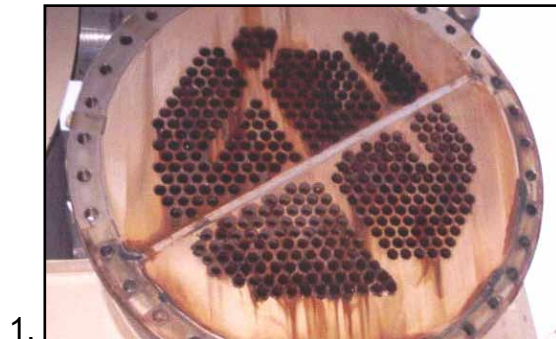
The flange of the heat exchanger was corroded preventing correct sealing.

1. General view of the flange
2. Surface preparation of the flange
3. Belzona® 1311 applied to the corroded areas
4. Flange repaired and protected
