BELZONA SAVES ROTOR AND MAINTAIN PRODUCTION

Carton Plant - Jordan

Rotor of Water Ring Vacuum Pump

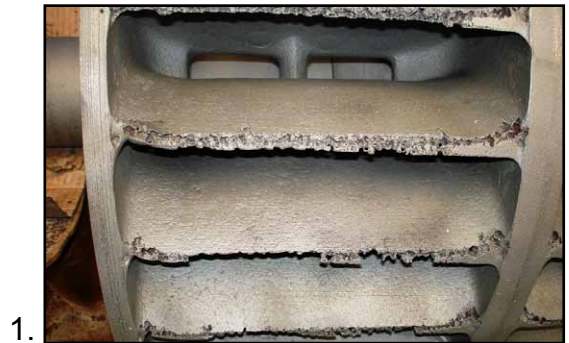
Severely eroded, no replacement available. New Rotor would cost \$11,000 USD.

1. Main body of rotor severely eroded
2. Rebuilding and reinforcing with Belzona® 1111
3. Top coating with Belzona® 1321
4. Ready to be in operation
