## BELZONA PROTECTS AUGER MIXER

Mineral producer, Massa, Italy

Screw auger used in production of Calcium Carbonate

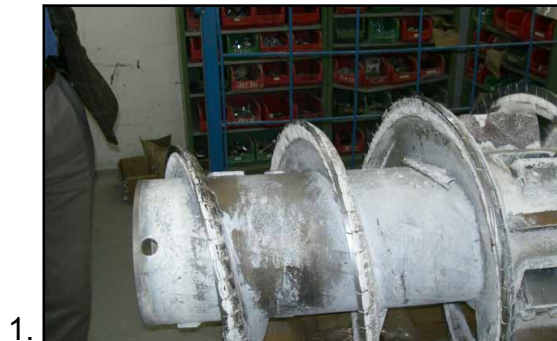
Severe abrasion wears shaft and flights. Hard inserts welded on edges.

1. Auger before refurbishment
2. Grit blasted and application underway
3. Partially coated with Belzona® 1321
4. Application almost complete
