BELZONA REFURBISHES MILITARY DOG KENNELS

Military Base, North Alabama

Floors and walls in dog kennels.

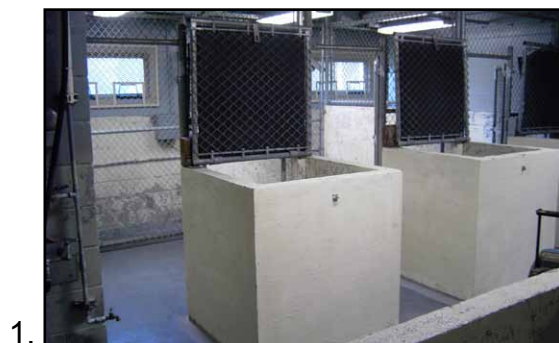
1. Prepped and ready to coat
2. Floor and coves covered
3. Almost complete, walls being coated
4. All done! Ready to turn over to the owners

This application was performed in accordance with Belzona Know-How System Leaflets FPA-3 & TCC-15. To create a non-slip surface that did not damage paws, different aggregates were tried before settling on a non-standard Belzona one that was found to be ideal. Coves between wall and floor were formed and Belzona® 5111 provided stain resistant finish.
