BELZONA FLEXIBLE MEMBRANE SEALS LEAKING CONCRETE DECK

Leaking concrete deck over parking garage

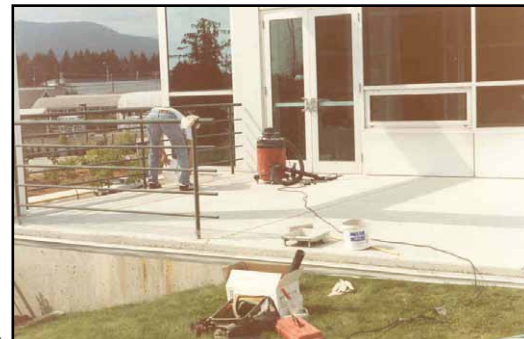
1. The deck prepared by pressure washing
2. After application of Belzona® 3911 to concrete surfaces and Belzona® 3921 Aluminum surfaces (window and door frames), Belzona® 3111 was applied
3. View of deck taken in 2005 after 10 years of service
