BELZONA PROTECTS AERATOR IN WATER TREATMENT PLANT

Waste Water Treatment Plant, British Columbia

Aerator in water treatment process.

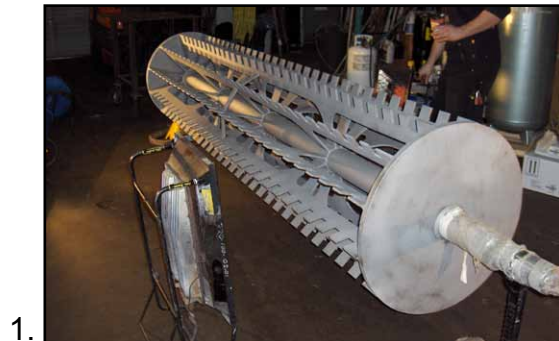
1. Completed aerator unit in the fabricating shop after grit blasting
2. Close up view of the equipment
3. Completed application, 2 coats of Belzona® 1321
4. Protected aerator in service
