BELZONA REBUILDS SEA WATER FILTER FLANGES

Gas Production Company, England

6 x Seawater Filter Baskets

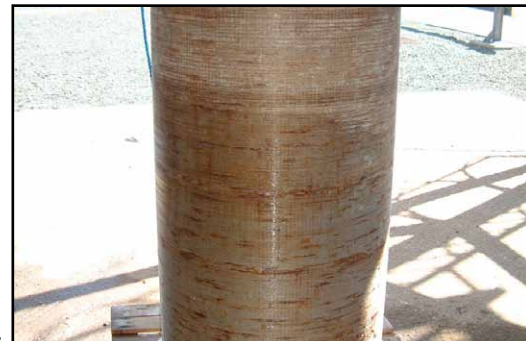
1. A section of a seawater filter basket
2. Severe crevice corrosion on 18 flanges
3. Belzona® 1111 in place and curing
4. Final result

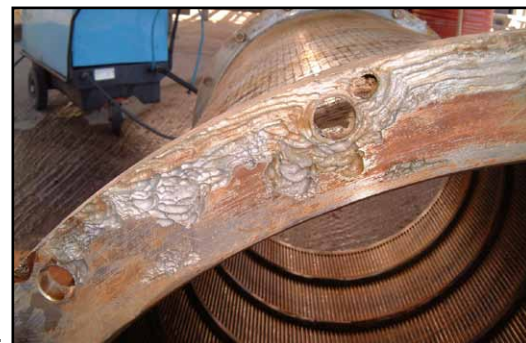
2.

Severe crevice corrosion and galvanic cavities on the flanges.

Application was carried out in accordance with Belzona Know-How System Leaflet VPF-13. A former was manufactured and with the use of spacers, clamps and release agent, the Belzona® 1111 was formed into perfect flange faces.
