BELZONA IN-SITU TANK REPAIR

Paint booth process water tank

Corrosion and leaking tank. To replace tank with new was costly and would result in production downtime of 7-10 working days.

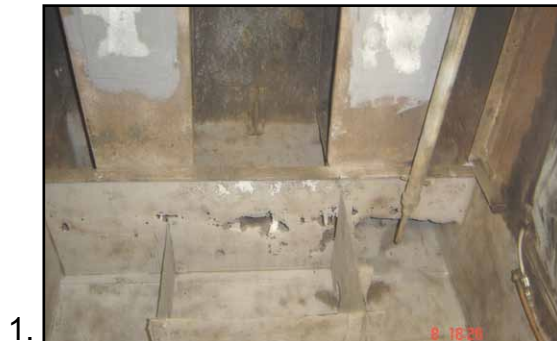
1. Tank cleaned and shot blasted
2. Vacuum column prior to plate being bonded
3. Remedial work/plates bonded in place
4. Tank complete after 2 coats of Belzona® 5811

Application was carried out in accordance with Belzona Know-How System Leaflets TCC-1 & -3. doubler plates were bonded over perforated steelwork before applying corrosion resistant coating.
