## BELZONA STEP NOSING REPAIR

Racecourse, Liverpool, England

March 2007

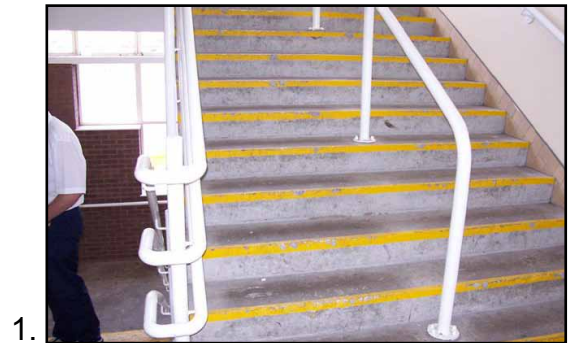
Porters had been bouncing beer barrels down the steps from the bar situated on the floor above. This was damaging the concrete step nosings.

1. Steps showing signs of damage
2. Close up of damage
3. Steps repaired
4. Close up of repair
