BELZONA ELASTOMER SEALS CONCRETE PARKING DECK

Shopping Mall - Vancouver, BC

November 2007

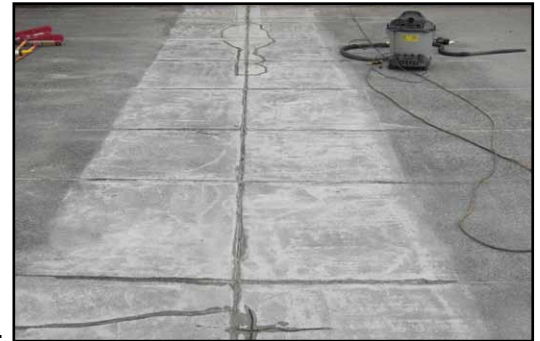
Various cracks and faulty seams on concrete parking deck.

A previous application by another contractor had failed in a very short space of time leading to water entering the shop below.

1. All joints were ground clean to remove all traces of the failed material
2. All joints were conditioned with Belzona® 2911 prior to injecting the Elastomer
3. Completed application with all the joints and cracks sealed

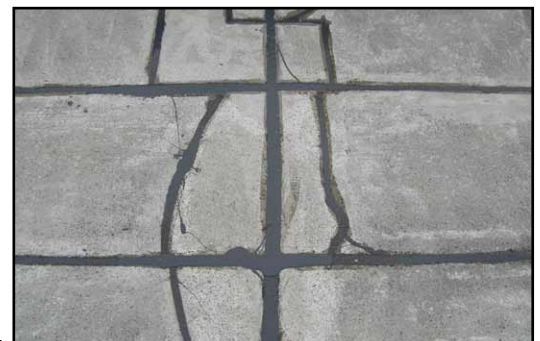
Heavy rains after the application had been completed revealed that the area was now completely water-tight.
