BELZONA REBUILDS LIFT PUMP

Waste Water Utility, Oklahoma

Lift station pump.

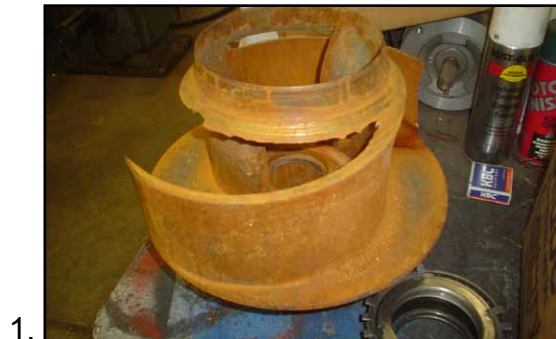
Pump had lost efficiency and had to be pulled. The model was foreign and had a four week lead time for parts.

1. Eroded impeller
2. Impeller reinforced and blasted
3. Blasted and coated bowl
4. Impeller after balance and rebuild

This impeller and bowl was rebuilt in a local repair shop using Belzona for 40% of the cost of a new one. The customer reported that when reinstalled the check valve has never gone higher!
