## BELZONA HOT OFF THE PRESS

Regional Newspaper, Leeds, UK

Conveyor belt carrying rejected newspapers.

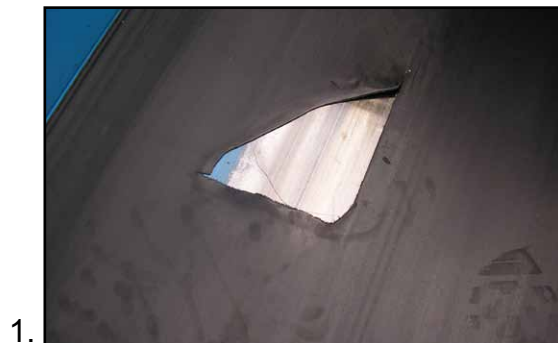
Large hole torn in the belt caused by a metal tool being dropped onto the belt.

1. Damaged belt
2. Preparation in progress
3. Finished application, with customer admiring his work
