ENGINE REPAIR WITH BELZONA

Komatsu 900 loader.

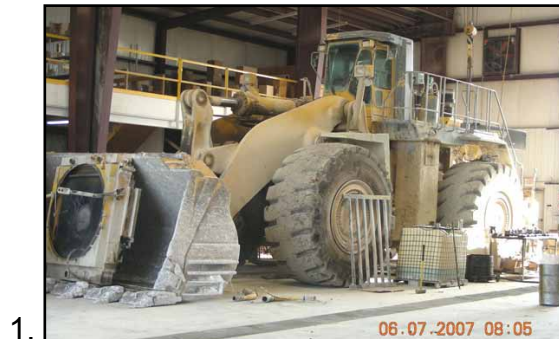
1. Komatsu 900 loader
2. Typical damage
3. Completed surface preparation
4. Finished repair to 1 of the 11 damaged areas

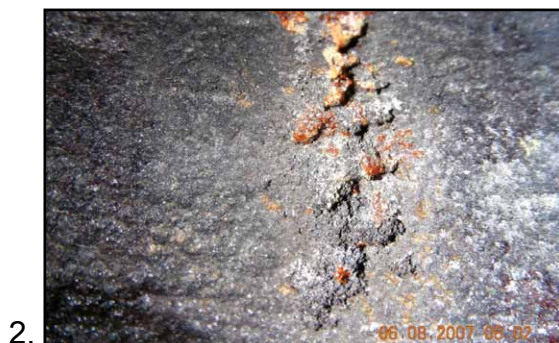
Erosion/corrosion on the cylinder block behind the cylinder liners allowed engine coolant to leak into the lubricating oil causing an engine failure.
