BELZONA WEATHERPOOFS POROUS STONework

Private House, Manchester, England

August 2007

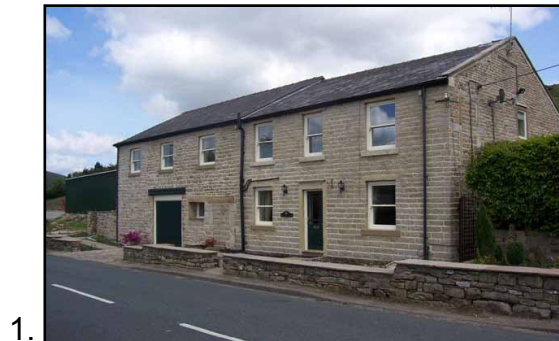
1. View of property
2. Windows masked up and ready to go
3. Applying Belzona® 5122 with spray unit
4. Application close up
