BELZONA SOLVES BALANCE PROBLEM ON IMPELLER

ConocoPhillips Refinery, Wood River, IL

July 2007

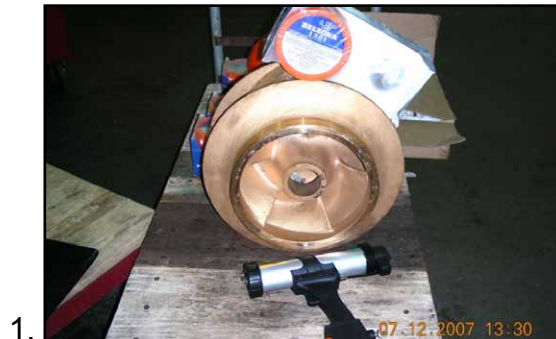
Impeller did not have a solid center bore. Instead, it had a boss fit on both sides with a 60 cubic inch void in the center.

Liquid slowly entered the void during operation causing an imbalance and vibration.

1. General view of the impeller
2. Injection port fitted
3. Injection underway
4. Vent port filled after injection completed

Belzona® 1321 was injected into the void, filling it completely. Application followed Belzona Know-How System Leaflet GSS-9
