POTATO AND STARCH PUMPS REPAIRED WITH BELZONA

Potato chip factory, Egypt

August 2006

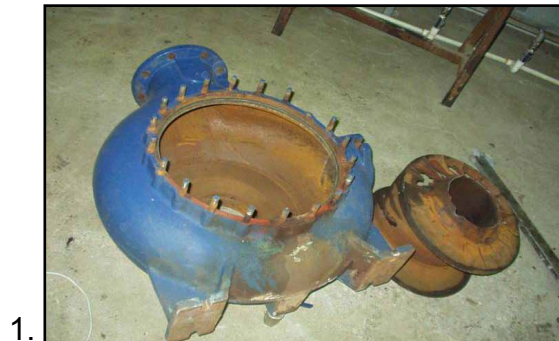
Two end suction pumps, one waste pump and the other a preheater pump. Both deal with water, potatoes and starch.

1. General view of one pump
2. The badly damaged impeller
3. Rebuilding the impeller
4. Two pumps rebuilt and coated

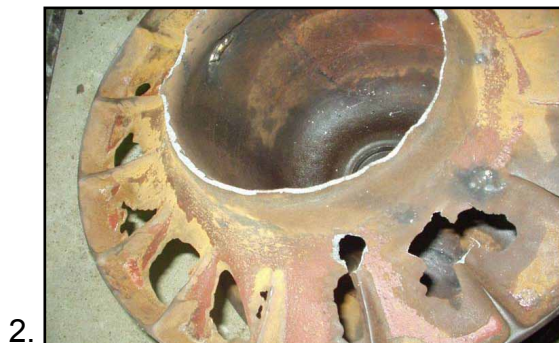
Corrosion of the casings and impellers caused over long service life and through erosion. The impellers were badly eroded with thin edges and many holes.
