BELZONA REPAIRS LEAK IN HOT ACID PIPELINE

Zinc Smelter - British Columbia

Cast valve handling hot Sulphuric acid

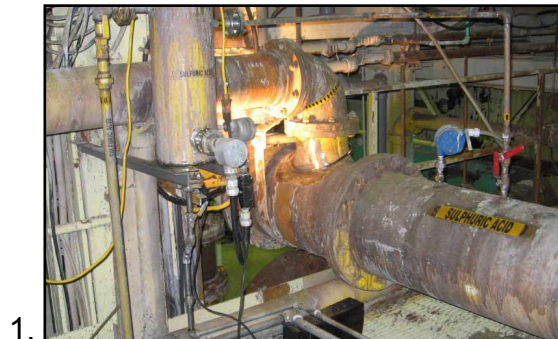
1. Overview of application situation
2. The hole in the valve is prepared by grinding
3. Completed application of 1st patch using Belzona® 1311
4. Completed application with fina patch of Belzona® 4301 and steel plate bonded in place
