## BELZONA PROTECTS HOT WATER TANKS

State Correctional Facility, Missouri

Hot water generation tanks within the Powerhouse.

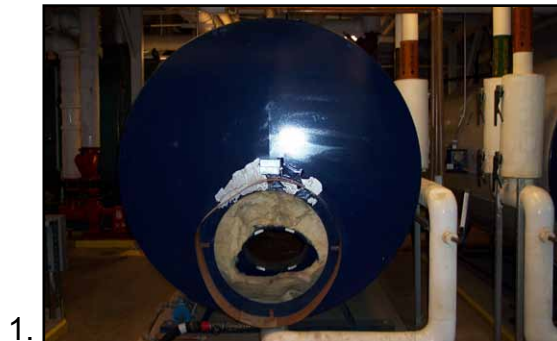
1. The tank inside the Powerhouse
2. View of the internal corrosion
3. Contractor applying 2<sup>nd</sup> coat of Belzona® 5811
4. Technical Consultant inside the finished tank 2 days later

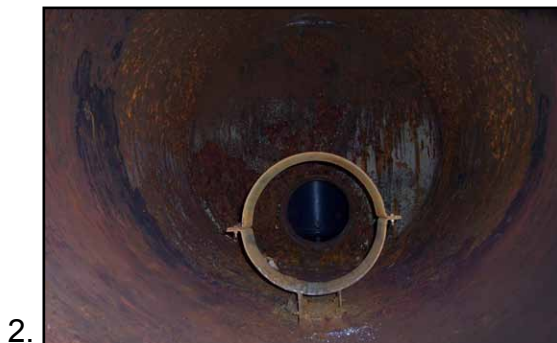
Severe internal corrosion
