## BELZONA PROTECTS LARGE RIVER PUMP

Petrochemical Plant, South Louisiana U.S.A.

Main cooling water pump handling river water.

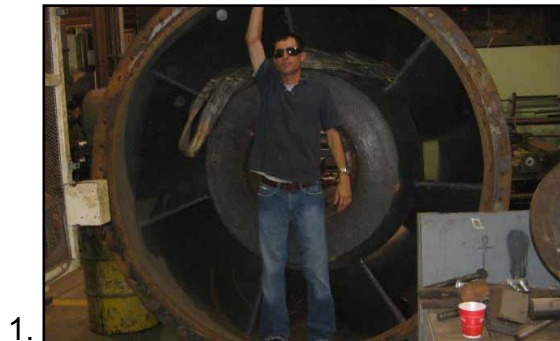
Pump was subject to erosion due to solids drawn from the river.

1. Scale of the pump clearly evident
2. Fully restored suction diffuser
3. Work beginning on restoration of impeller
4. Fully protected impeller
