## BELZONA PROTECTS DISULFIDE SEPARATOR DRUM

Refinery - Westlake, Louisiana U.S.A.

Corrosion and severe pitting on the inside of a process drum.

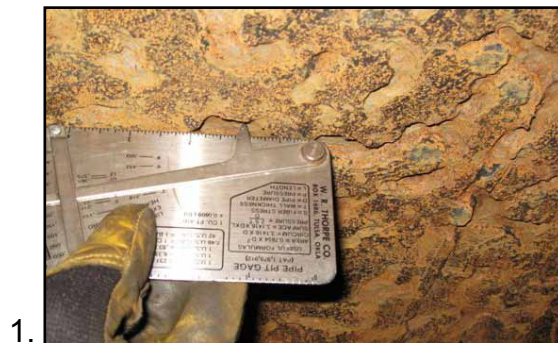
Chemical attack in the vapor space of this drum was evident after 5 years in service.

1. Severe pitting on the vessel roof
2. Severely corroded vessel to chimney joint
3. Completed chimney stack
4. Completed vessel roof

Belzona® 1111 (Super Metal)

Belzona® 5891 (HT Immersion Grade)

Application was carried out in accordance with Belzona Know-How System Leaflet TCC-3.
