COAL CONVEYER REPAIRED WITH BELZONA ELASTOMER

Power Plant, Missouri

2007

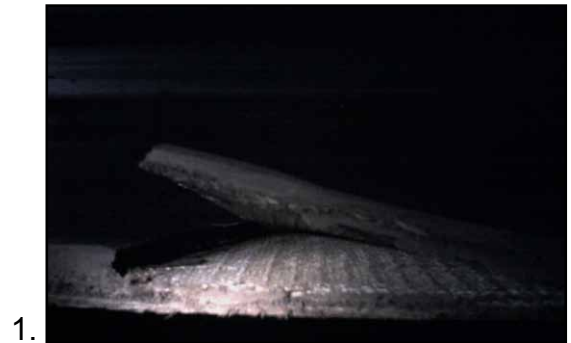
The belt had delaminated and lost the top two plies in areas. Plant officials worried that the belt integrity was in jeopardy due to the extensive damage.

1. Belt damage
2. Another view of the damaged area
3. Application underway with reinforcement tape being embedded in elastomer
4. Completed repair
