## BELZONA SAVES MORE THAN 1 BILLION US DOLLARS

Potash Producer, Jordan

Diffuser end section from main intake lift pump station handling highly saline sea water.

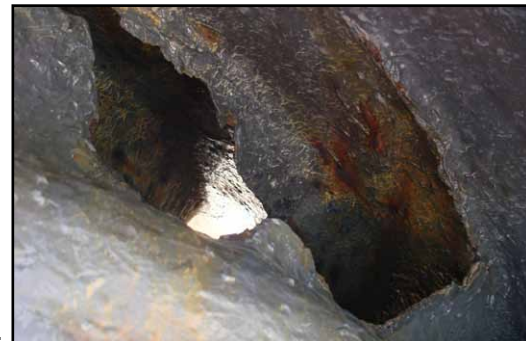
Extreme erosion & corrosion of the internal body. Fifteen vanes badly eroded.

1. Body & Vanes severely damaged
2. Application team at work after Blasting and Sweet Water washing for 6 days to remove heavy salt contamination
3. Final touch-up
4. Smooth operation after 2 months, pumping 18,000 Cu.m/hr
