BELZONA SEALS SKYLIGHTS ON JET HANGER

Private Airport Services, North Alabama U.S.A.

October, 2007

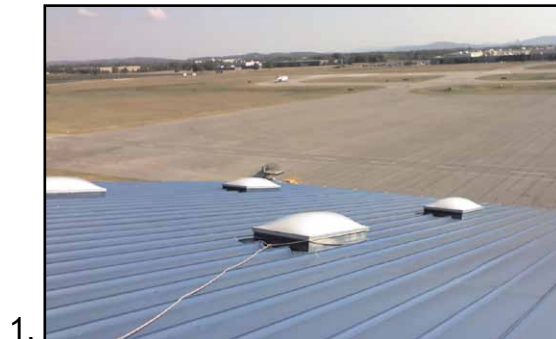
The roof of the hanger has 16 skylights and each one leaked. Several earlier attempts to seal skylights proved futile.

1. Skylights with runways in background
2. Taped off and ready to coat
3. Belzona® 3111 1st coat going on
4. Finished job. No leaks - no problems!

Applied utilizing Belzona Know-How System Leaflet RPA-3. Skylights were pressure washed clean, taped off areas around skylights to include joints and seams, applied Belzona® 3921 and 2 coats of Belzona® 3111 Flexible Membrane with Belzona® 9311 Reinforcing Sheet.
