BELZONA REPAIRS BROKEN INSULATORS

Power Distribution company, France

July 2008

Electrical Insulator in a distribution sub-station.

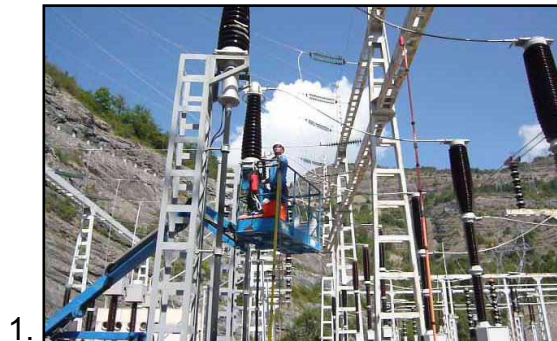
1. General view of the sub-station
2. Broken insulator
3. Repair completed
4. Close up showing exact reproduction of the original profile

Pattern for the broken area taken from sound area using Belzona Elastomer. This then used to mold Belzona® 8111 to re-create original profiles

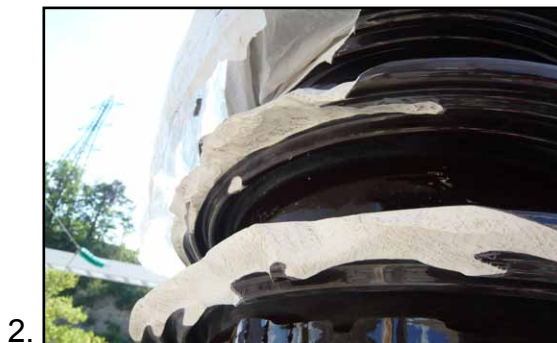
Broken insulator, compromising safety on site.

The insulators are old and replacement is nearly impossible as similar items are no longer available. The option of repairing with Belzona® 8111 has been chosen because of the electrical properties of the product. The repair was done on site by the application team, who completed the job in a few hours.
