## EXPANSION JOINT AT HOSPITAL SEALED WITH BELZONA

Hospital, Missouri

Expansion joints in corridor in need of repair

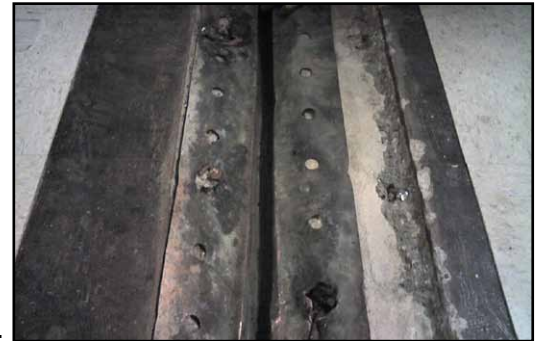
Expansion joints in the hospital had become a tripping hazard

1. View of joint with kick plate removed
2. Application of Belzona® 4111
3. Application of Belzona® 2221
4. Completed application
