BELZONA REFURBISHES LABORATORY WORKTOPS

State Health Dept.

March 2005

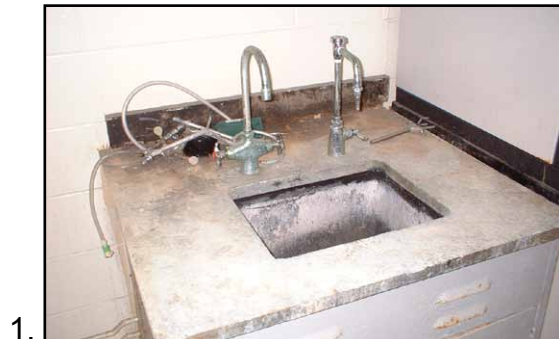
Severely degraded counter tops needed to be resurfaced with a chemically resistant coating.

1. Sink in lab before work
2. Fume cupboard before work
3. Sink after coating
4. Counter top after coating

Application carried out in accordance with modified Belzona System leaflet FPA-3. Special care was taken to clean sand the surfaces. Belzona® 5811 applied over-thickness with a trowel to create a self levelling coat.
