## IN SITU SHAFT REPAIR WITH BELZONA

Mixer Vessel drive shaft

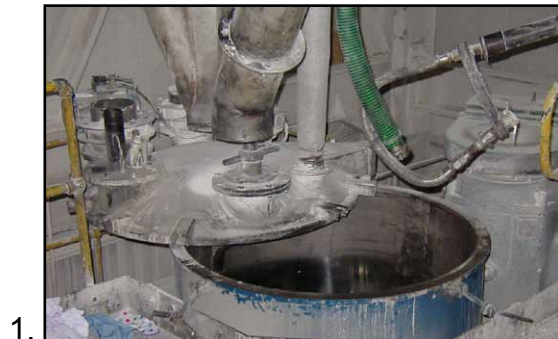
1. Mixer Vessel
2. Failed Metal Sprayed Shaft
3. Form tool in position
4. Finished Shaft

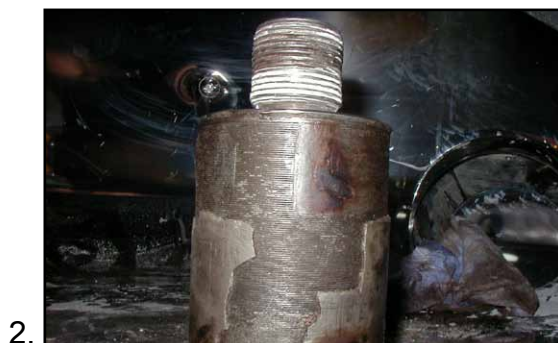
Customer had un-scheduled failure of mixer vessel drive shaft which had previously been repaired using metal spraying.

Old metal sprayed material was totally removed and shaft rebuilt using Belzona System Leaflet MPT-2. Former was made to allow repair to be completed in-situ.
