FORMING NEW MANWAY SEALING FACE

Oil Major, North Sea

March 2006

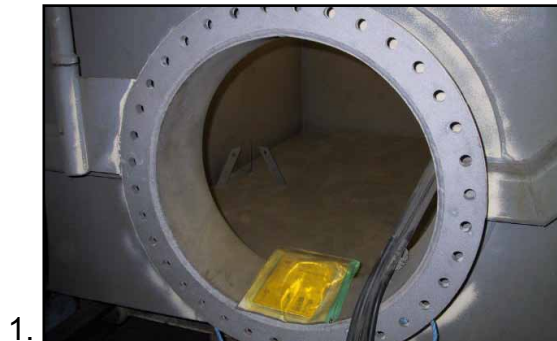
1. Manway blasted ready for forming
2. Former and specially fabricated shim inserts
3. Forming the Manway
4. Manway formed ready for service.

Hot work was not permitted so a weld overlay was not feasible and the finished job required to be a sealing face so hand coating was not deemed suitable. Belzona provided a perfectly formed corrosion resisting sealing face.
