BELZONA PROTECTS CW PIPES AND BENDS

Power Station, UK

Main intake pipework drawing sea water into the power station.

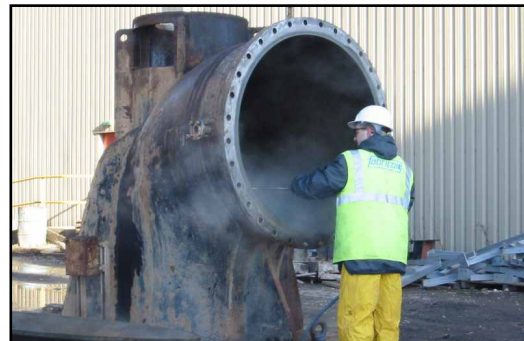
As a relatively new power plant on the banks of tidal estuary, the CW pumps and ancillary pipe work were showing significant erosion and corrosion after a short period of service. They were pumping large volumes of water from the river, which is very erosive even after it has been screened.

1. Bend being power washed to remove salts
2. & 3. Coated bend

Application was carried out in accordance with Belzona Know-How System Leaflets VPF-1 & VPF-2. Particular attention was paid to washing and blasting to remove salts, then badly eroded areas were re-built with Belzona® 1311 and then two coats of Belzona® 1321 applied.

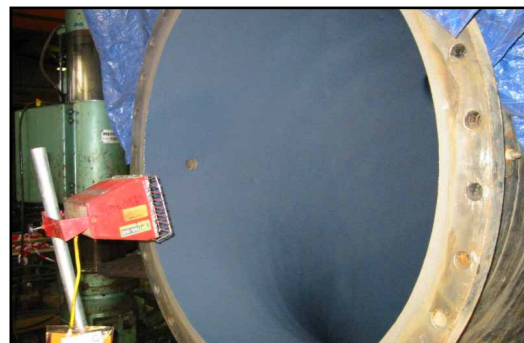
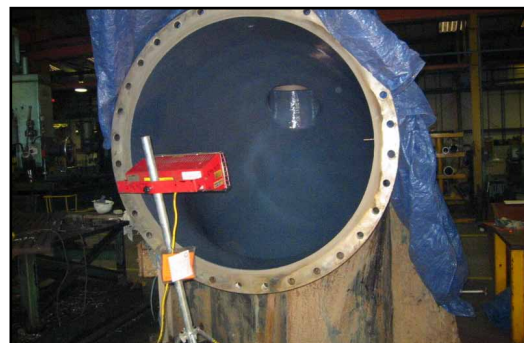
The first bend, which is shown in the photographs, was opened up in March 2007 with a view to being refurbished. However when it was inspected, it was found to be in perfect condition.
