BELZONA PROTECTS BRINE PUMP BOWLS

Hydrocarbon Fractionation Facility / Hutchinson, KS

January 2007

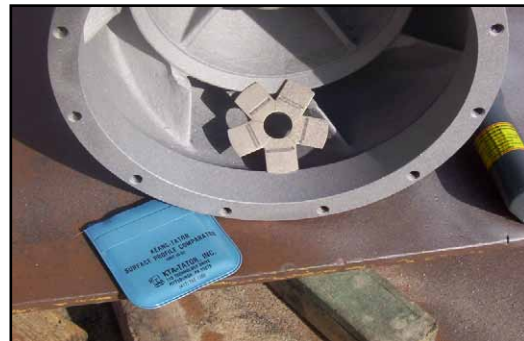
1. Grit blasted bowl with surface profile sample
2. Mixing Belzona® 1321
3. Application under supervision in progress
4. Pump bowls with Belzona® 1321 applied

Application was completed in accordance with Belzona Know-How System leaflet CEP-3. The pump bowls were heated to a pre-application temperature of 90 °F.
