BELZONA MAINTAINS FRANCIS TURBINE

Power Plant, Honduras, Central America

Complete Overhaul of all the parts and sections of a Francis Turbine. The turbine needed maintenance after 15 years of operation.

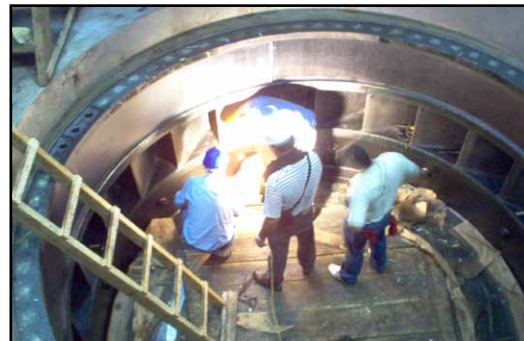
1. View of diffusers
2. Damage in seal perimeter
3. Machined area prior application of Belzona® 1111
4. Final application of Belzona® 1111 and Belzona® 1321

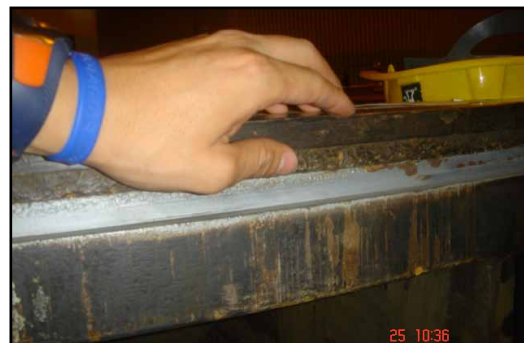
2.

The water had produced an erosion/corrosion effect in several sections of four different parts of the Turbine. The biggest damage was located in the seal perimeter of the facing plate.

The customer decided to make a complete maintenance using Belzona's products after we had repaired the shaft in 2004 with excellent results. The actual damaged part had a diameter of 3.8 m which was rebuilt, machined and rectified to precise measurements for its assembly.
