BELZONA ELASTOMER REPAIRS TO AGITATOR IN FGD UNIT

Power Station, Lawrence, Kansas

September 2007

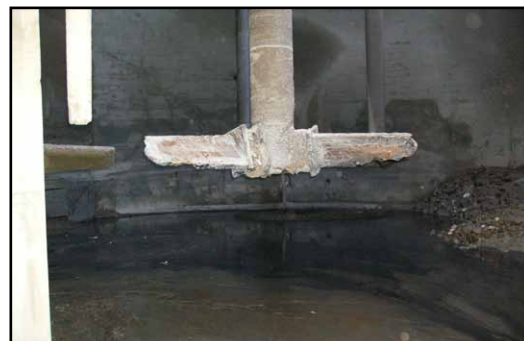
Rubber clad blades damaged through impact and abrasion. Each shaft has three blades and there were four shafts.

1. General view of the plant
2. The Crystallization Tank Mixer
3. Application crew in action
4. Completed application
