## BELZONA SEALS CONDENSER EXPANSION JOINT

The #4 generator condenser expansion joint.

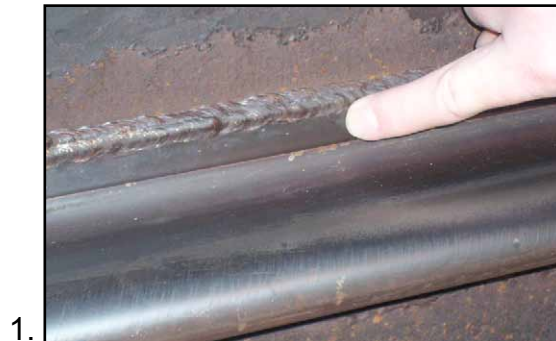
The efficiency of the unit was low because of the leaks in the expansion joint.

1. Leaking expansion joint
2. Mixing Elastomer
3. First coat
4. Second & Third coat

Application was carried out in accordance with Belzona Know-How System Leaflet HEX-5. The surface was prepared with a vacublast unit. After Conditioning, three coats of Elastomer were applied to the expansion joint and approximately one inch beyond the joint.
