## DRIVE ROLLER GETS BELZONA GRIP SYSTEM

Cement plant, Bulgaria

Conveyor belt drive roll with diameter 1000 mm.

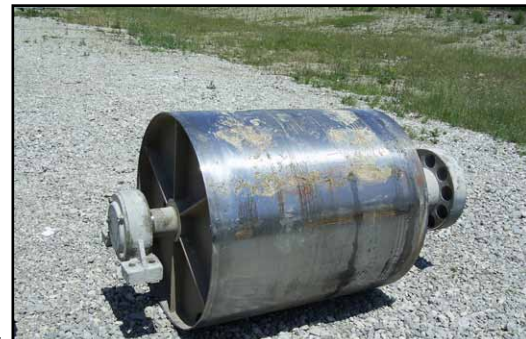
1.

The drive roller had no lagging and was exposed to the weather conditions causing loss of grip and slippage.

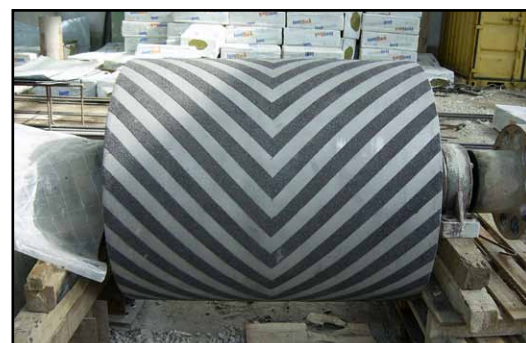
Belzona solution was half the cost and faster to apply than conventional hot vulcanization. The roll was prepared and the system applied without leaving the facility. At the end of 2007, the system is still in perfect condition and the client is considering application to another unit.

1. Roller prior to application
2. Surface preparation by blasting
3. Chevron pattern was created
4. Completed application
