## BELZONA EXTENDS RUBBER PUMP LINER LIFE

Power Station, Poland

Warman pump circulating Gypsum slurry

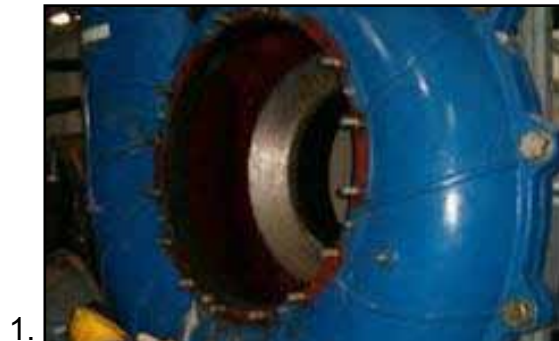
1. General view of the pump
2. First coat applied
3. Second coat
4. completed application
